EVALUATION OF
SETTLEMENTS AT THE
CONQUISTA TAILINGS
IMPOUNDMENT

Thesis

Master of Science in Engineering

The University of Texas at Austin
December 2012

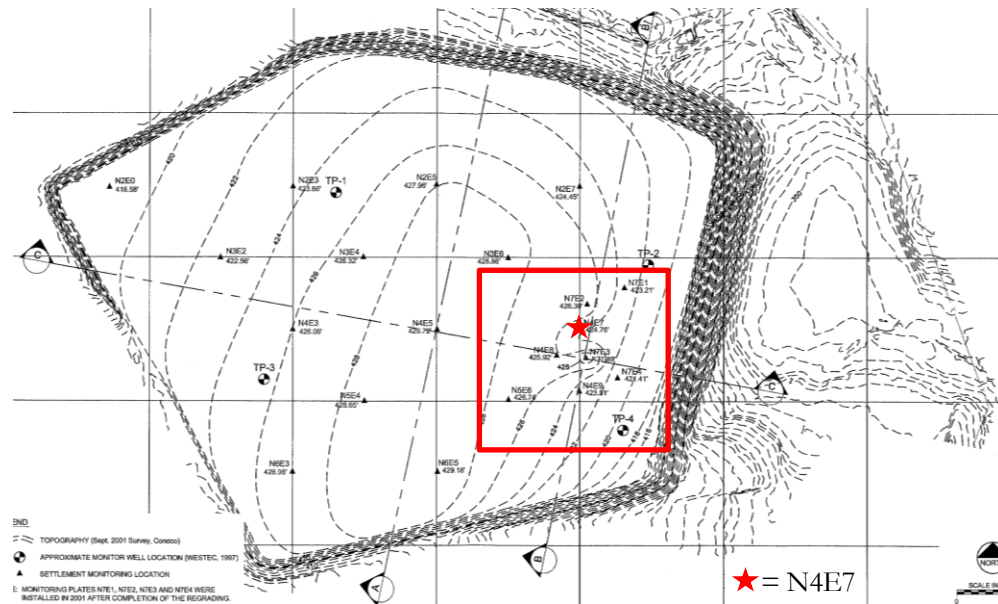
FIGURE 11 – Area of Concern (Conoco Phillips, 2011)

Beginning in 1993, after the final cover system was installed, settlement data was collected in the field. FIGURE 12 shows ground surface elevations (AMSL) versus time at the locations of interest, FIGURE 11.

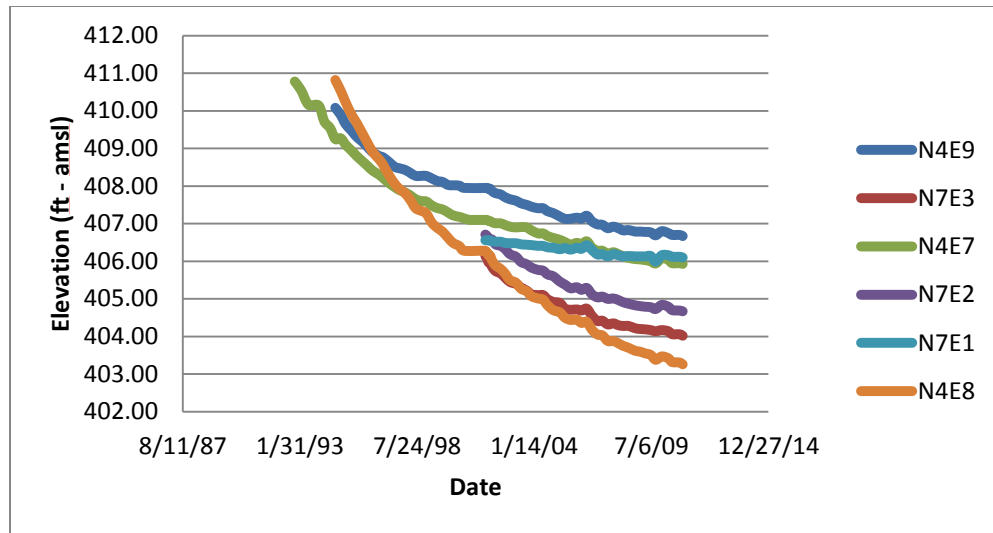
FIGURE 13 – Top of Tailings Elevations

This additional lift of fill material added to the eastern portion will be considered the second loading factor. By removing the depth of the cover system and the second lift of additional fill, the settlement data can be reconstructed to determine the elevation of the tailings surface. FIGURE 13 is a plot of the elevation of the tailings surface (Tetra Tech, Inc., 2004).

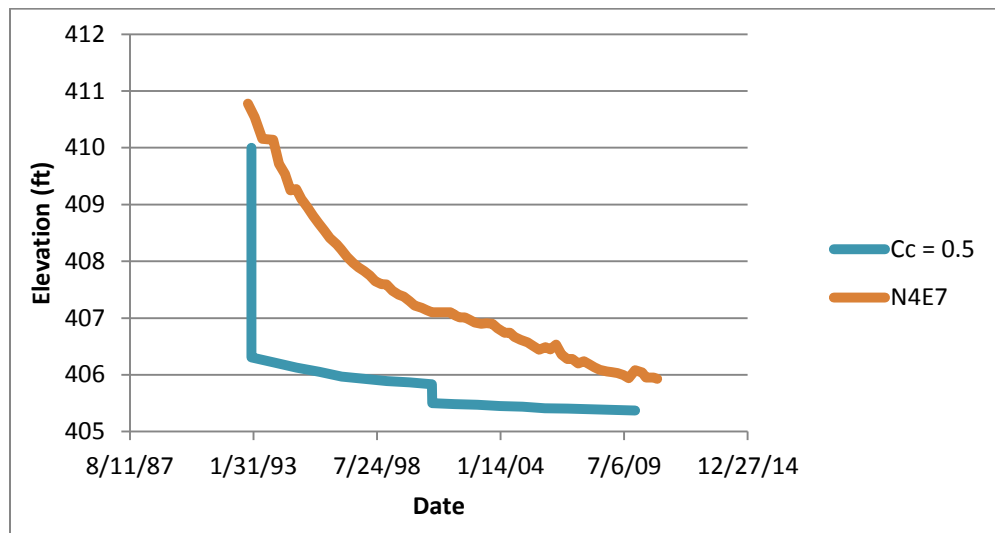
FIGURE 17A - Approach 1 ($C_c=0.5$) with N4E7 Settlement Monument Data

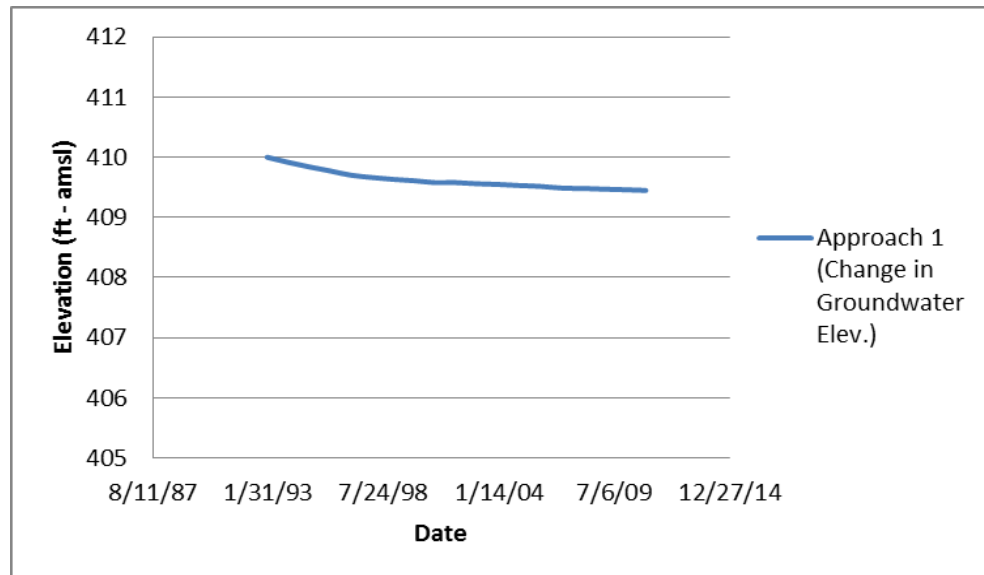
The vertical lines shown on the graph are directly related to the immediate loading of the cover system in 1994 and the additional lift added in 2001. When these settlements are removed, the settlement data remaining is only due to the lowering of the water table, as shown in FIGURE 18. As expected, the settlements predicted with Approach 1 exceed the actual monitored settlements at any given time. This can be attributed to the assumption that the excess water pressures will dissipate at the same rate at the reduction in ground water elevation.

FIGURE 18 - Approach 1 Settlement due to Change in Water Table Elevation

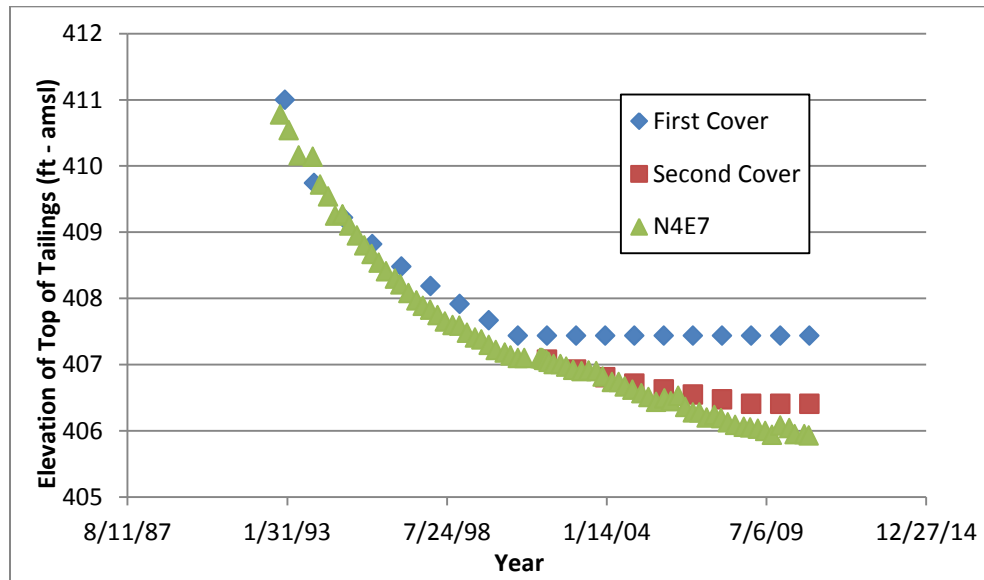
FIGURE 20 - Approach 2 ($C_v=120 \text{ ft}^2/\text{day}$) with N4E7 Settlement Monument Data

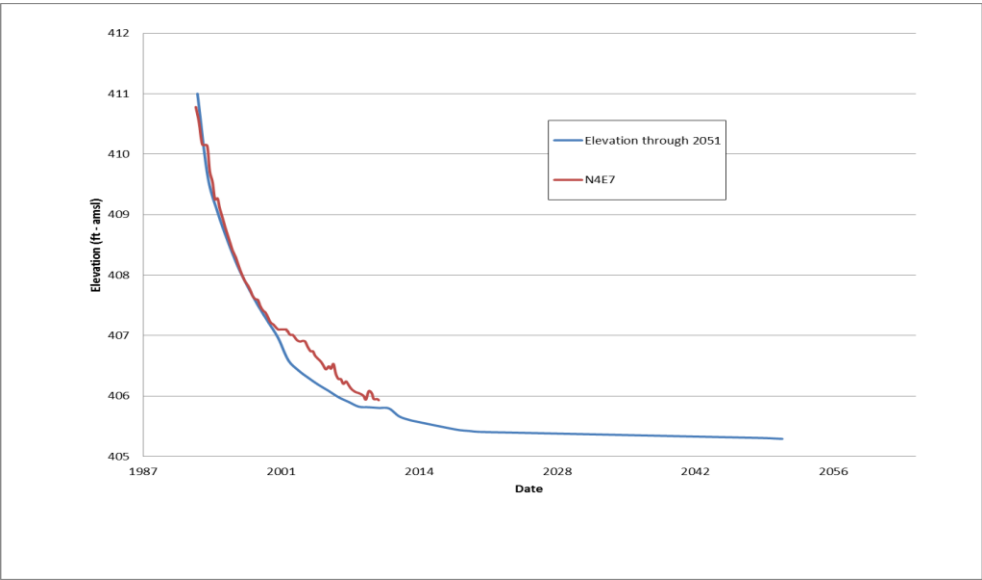
Approach 2 indicates that the settlement caused by the second cover has completed and the remaining settlement will be caused by the lowering of the water table. Assuming the parameters of consolidation and rate of water table reduction (0.5 ft/yr) remain constant with the continued settlement the settlement is projected to be completed in 2051 with an additional settlement of 0.24 feet to a final tailings surface elevation of 405.62 feet. FIGURE 23A shows the current N4E7 settlement data along with the settlement through 2051. This prediction is based solely on the fact that there will be no additional loading sequences placed at the surface and that the water table will continue to drop to the base of the tailings. The remaining settlement will then be due to the final consolidation of the tailings, due in part to the drop in the water table. In the case of an additional six (6) feet of fill placed the final settlement is reflected in FIGURE 23B and it increase the total settlement by 0.33 feet and will bring the final tailings surface elevation to 405.29 feet above mean sea level. Because the assumption that the fill will not compress or settle was used, the 20 feet of fill above the tailings surface (10-foot thick fill and cover system , 5-foot thick fill in 2001, 6-foot thick additional fill in 2014) the final surface elevation will be close to 426.29 feet amsl depending on the actual thickness of the material.

FIGURE 23B - Ultimate Settlements with additional fill in 2014 (Through 2051)

As previously stated, further characterization of the tailings material is recommended, as it appears that significant assumptions have been made regarding the compressibility parameter and the time history of settlements. These parameters and results can be significantly refined with the availability of additional experimental and monitoring data. To date, the data that was available for consolidation analysis dates back to 1987 and is from the Western portion of the site. The values reported in those reports sets the compression index at 0.2, while the data shown in this reports yields a value closer to 0.5. With more laboratory tests on sampled tailings material, the analysis could be greatly refined.
